**Crawford Station MGP Site  
Chicago, Illinois**

**Weekly Field Progress Report**

Report Date: March 22, 2012

**Subject: Site Remediation – Construction Management  
Peoples Gas – Former Crawford Station**

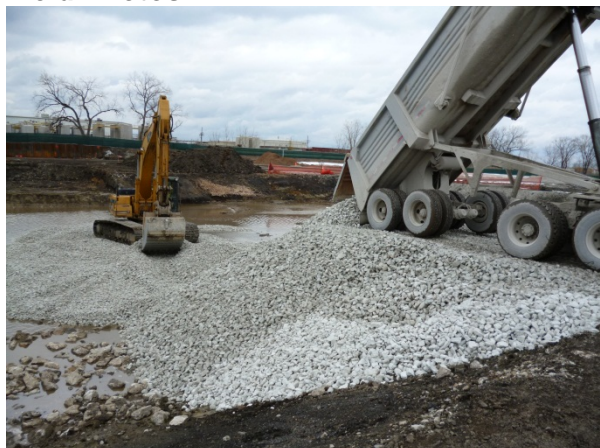
Photo 1: View of crushed limestone being used for backfill

Direction: Facing west.

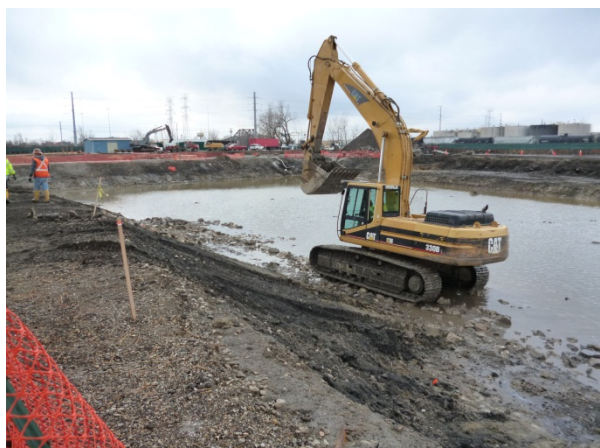
Photo 2: Area O/P/Q/R being backfilled.

Direction: Facing southwest.

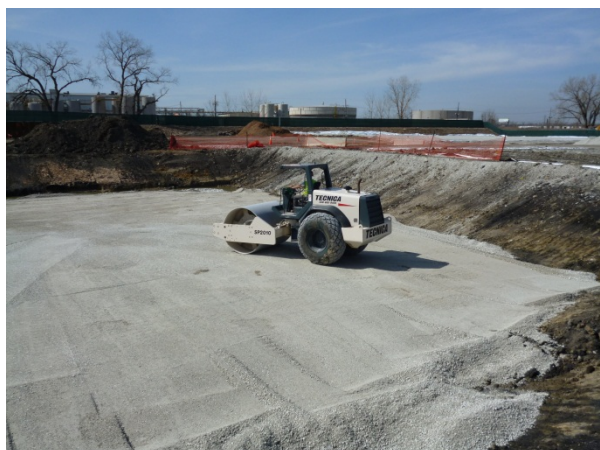
Photo 3: Backfill being compacted

Direction: Facing west.

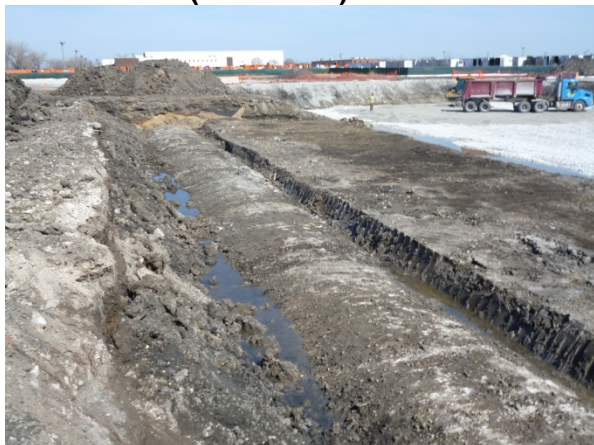
Photo 4: View of the exposed sewer

Direction: Facing north.

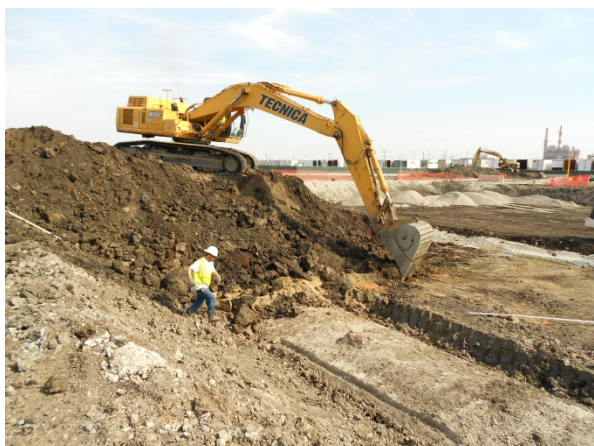
Photo 5: View of north end of Area AA being excavated

Direction: Facing north.

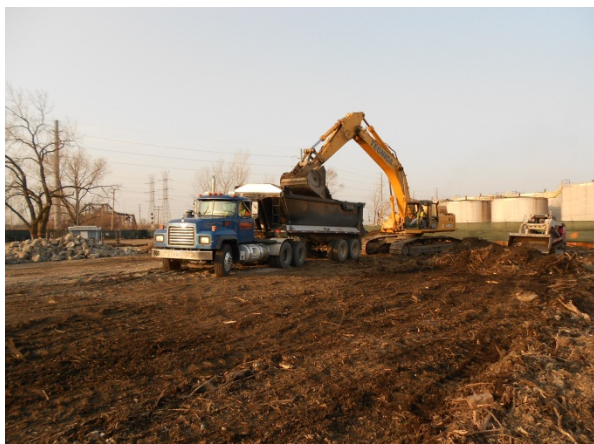
Photo 6: Stockpile and truck loading area for Area I.

Direction: Facing southwest.

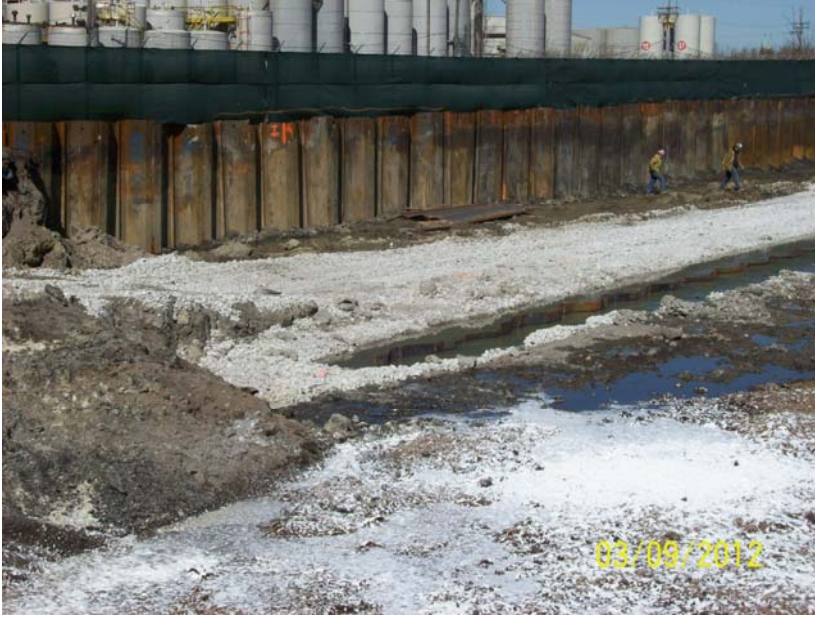
Description: Looking northwest at 10-foot excavation along west property line sheeting wall. Anchor wall for bracing has been driven to depth.

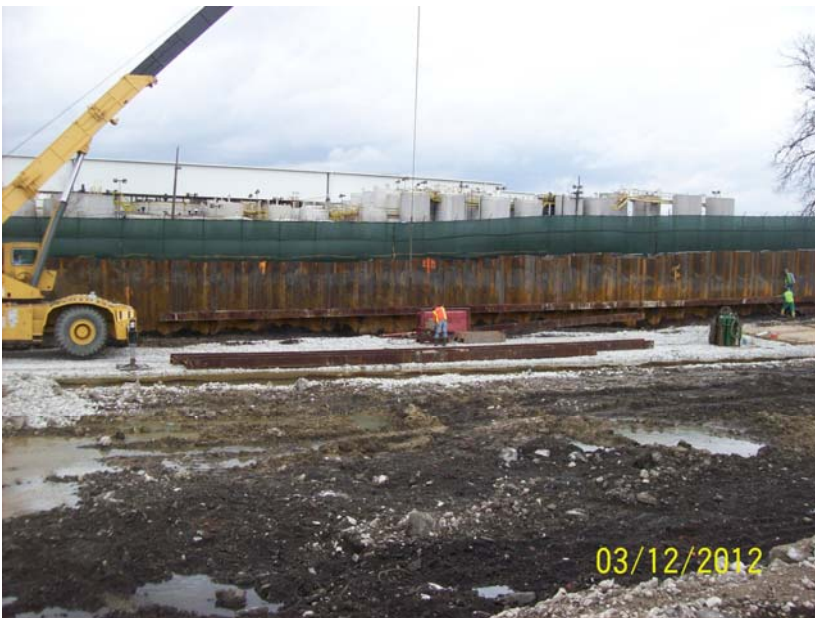
Description: Welding walers for bracing on the west sheeting wall. View is to the west.

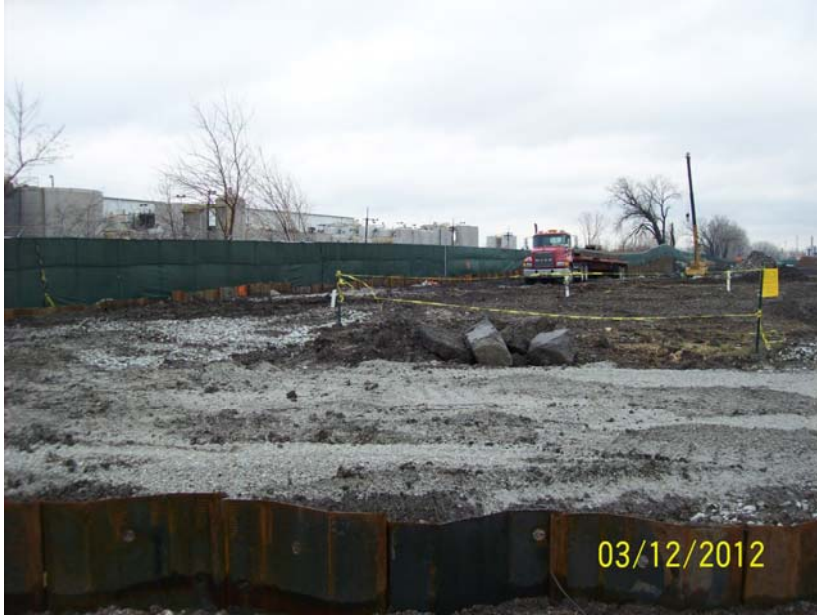
Description: The southwest corner of the work area, with white PVC pipes on top of anodes with the wires attached. Five anodes located by hand digging. Looking northwest.

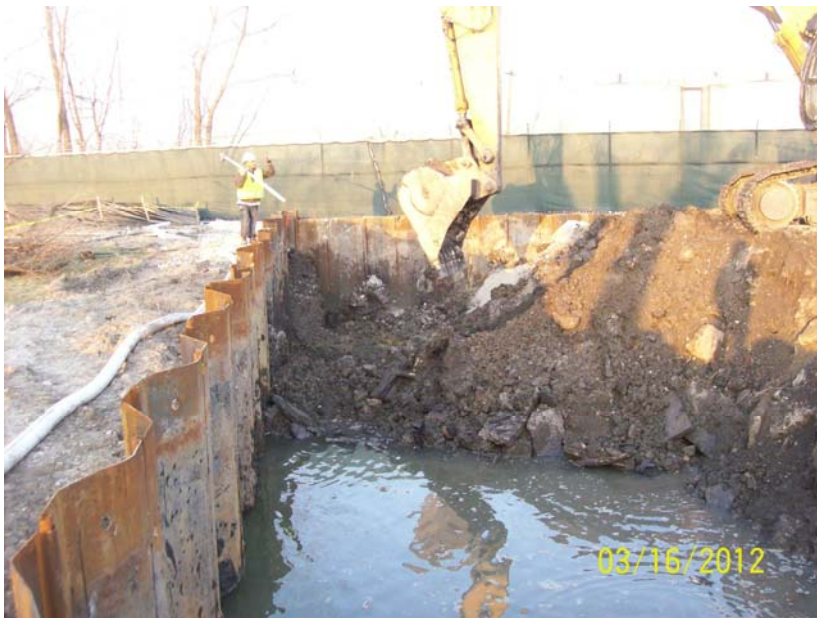
Description: Excavating to 8 feet in southwest corner of sheeting. Area is full of concrete debris, asphalt, pieces of brick walls. Very little backfill material was available here. View is to west.

- Areas L, M, and N top 8 feet full of concrete, asphalt, bricks, and other debris that required landfill disposal, with only small amounts usable as clean overburden backfill; and
- ComEd had not correctly identified the voltage in the feeder lines into the northeast corner of site (by the construction trailers, etc.), and have now told us they can only supply 480v power. This requires Helm Electrical Services to prepare and supply a transformer on site as an additional piece of equipment for 120v service. ComEd's costs would have been much higher to put up a pole with new transformers to give us the service for 120v, and would have delayed service several more weeks.

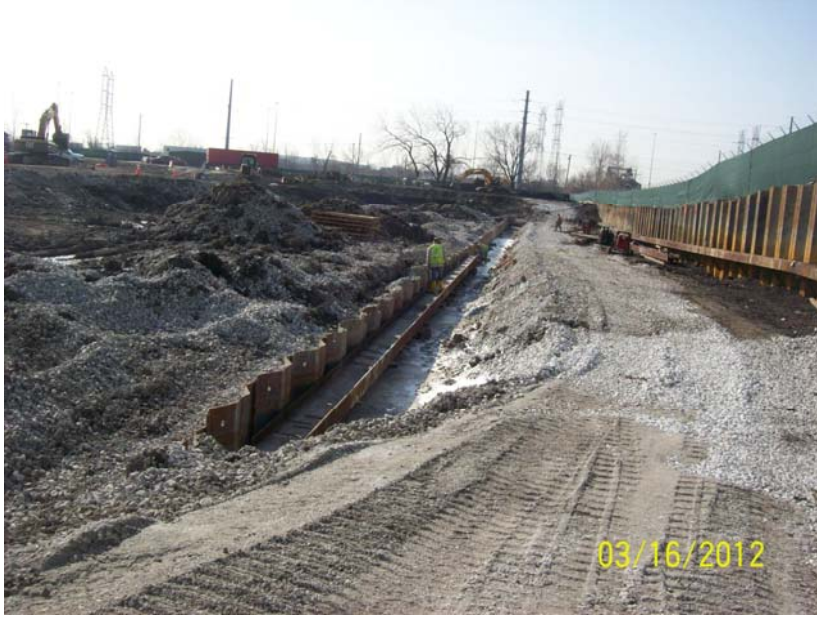
Description: The first walers have been welded in place on anchor wall sheets in preparation to install bracing rakers. View is to the south.

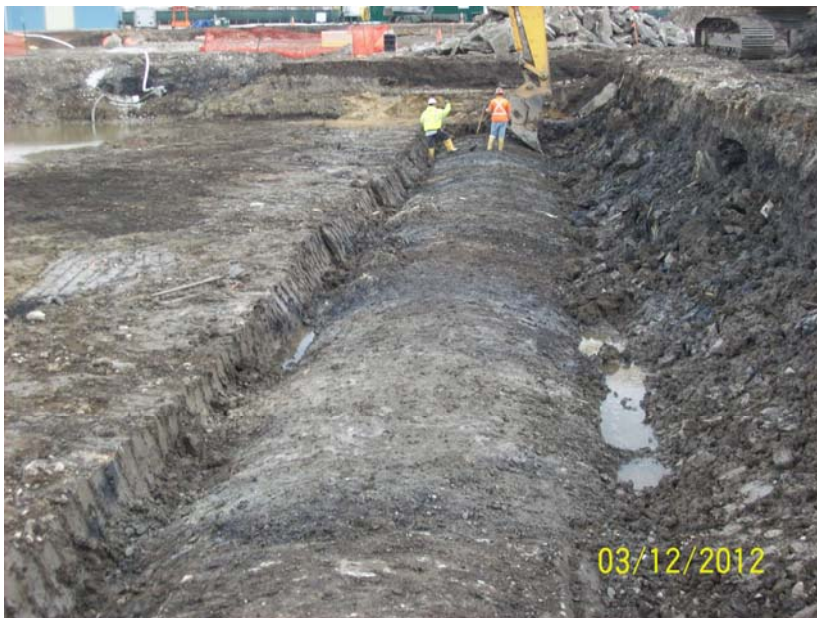
Description: Looking to south at the arched concrete roof of the large sewer running from the north to the south in the middle of the work area.

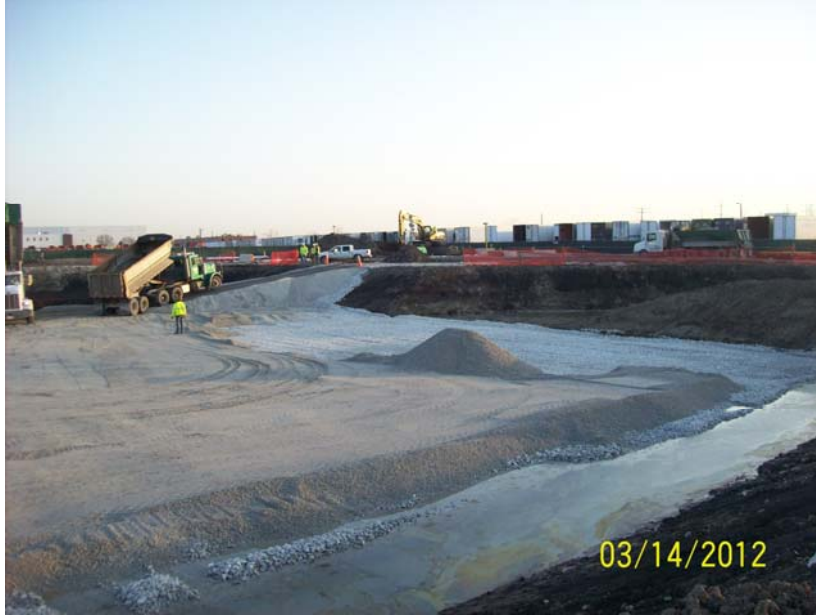
Description: Backfill being placed in Areas O, P, Q, and R. The layer of water-bridging CA-1 stone is being locked in place with compacted CA-6 on top. View is to northeast.

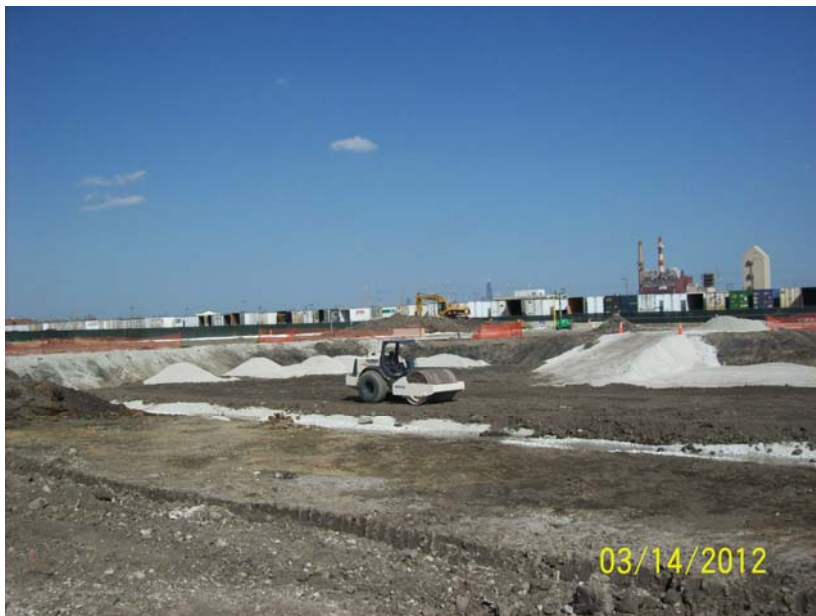
Description: Looking to northeast across Areas Q and R, at the first lift of clean overburden soils used as backfill, being compacted by vibratory roller.
